DUTCH BARN PRESERVATION SOCIETY NEWSLETTER

SPRING 2009

A Rare One-Aisle Barn with Basement

By Gregory D. Huber

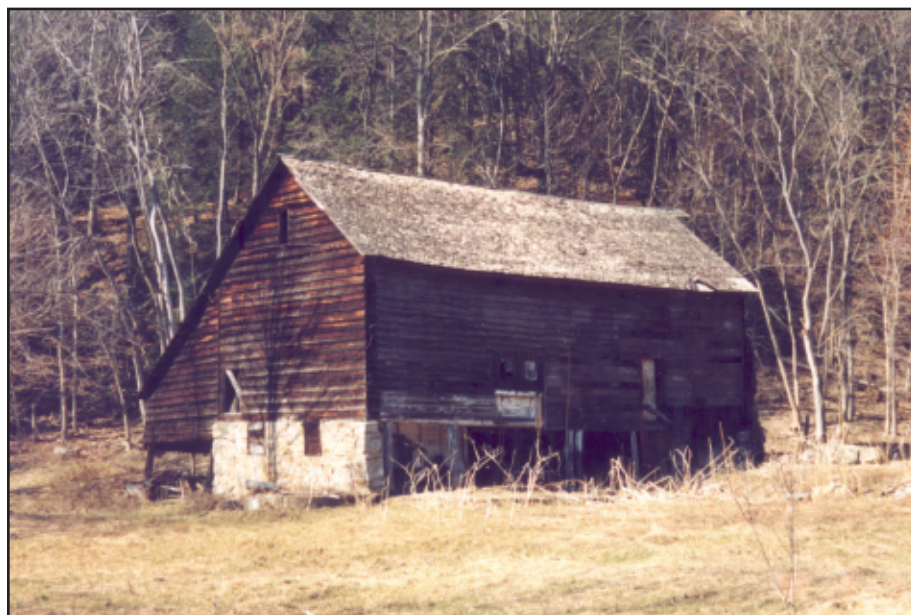
Photo 1. The LeFevre barn in April 2003. Wood roof shingles are plainly seen along with horizontal weather-boarding. At left on the basement level is the recess which initially suggested a possible connection to Pennsylvania fore-bay barns.

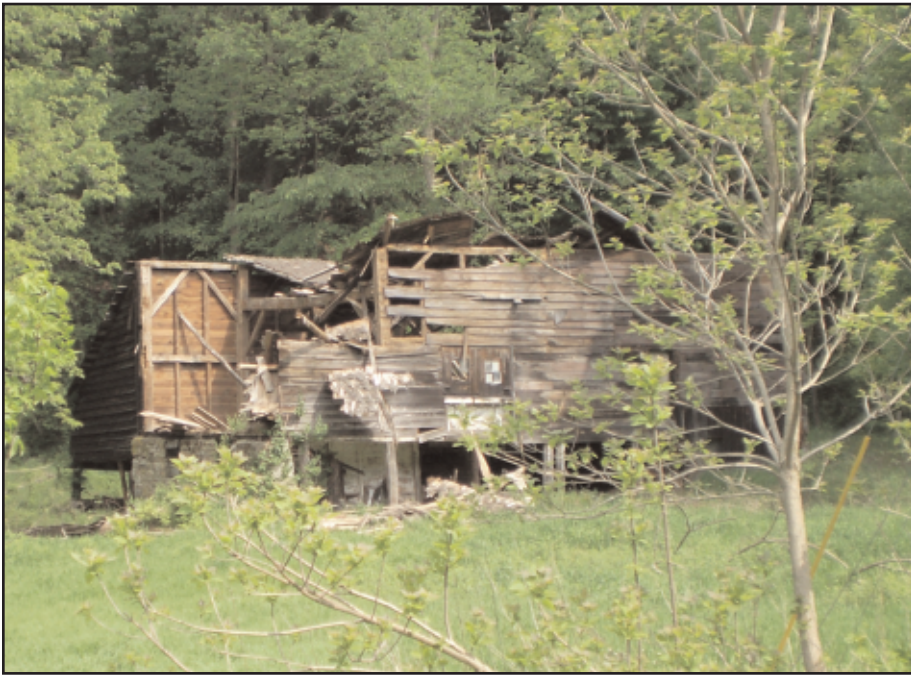
Bob called me and I told him that the barn was strictly of Dutch-American design. Remaining curious, he visited the structure in November 1996 and was satisfied that it was not at all a Pennsylvania fore-bay type barn. In April 2003 the author returned to the site and documented the barn by measuring it and taking photographs of its exterior. The structure was then in generally good condition but it is now in a ruinous state with a collapsed roof and partially ruined exterior walls (Photos 2 and 3).

Photo 2. The LeFevre barn with roof collapsed, May 2009. The side walls remain mostly intact but the south end wall has fallen. Trees have been encroaching on the barn for a number of years.

funding to restore the barn unfortunately did not come to fruition. In the past year or two the roof collapsed destroying many of the major timbers. Fortunately the LeFevre barn owner by virtue of their deep interest and concern allowed the barn to be recorded in 2003; it is now impossible to do any really meaningful recording of the barn.

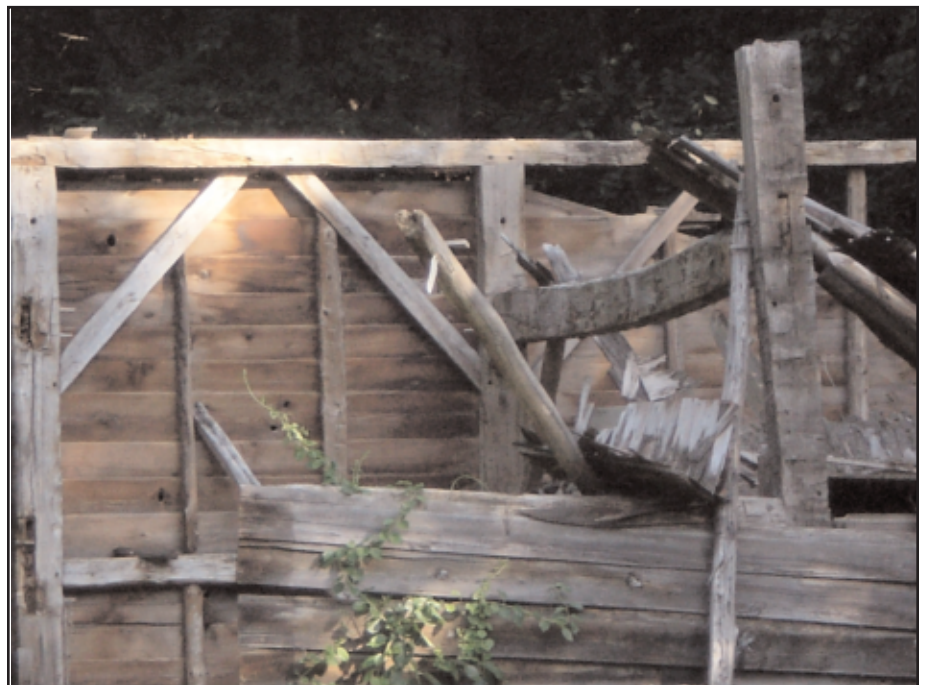
Photo 3. Detail of barn, showing anchorbeam, August 2009.

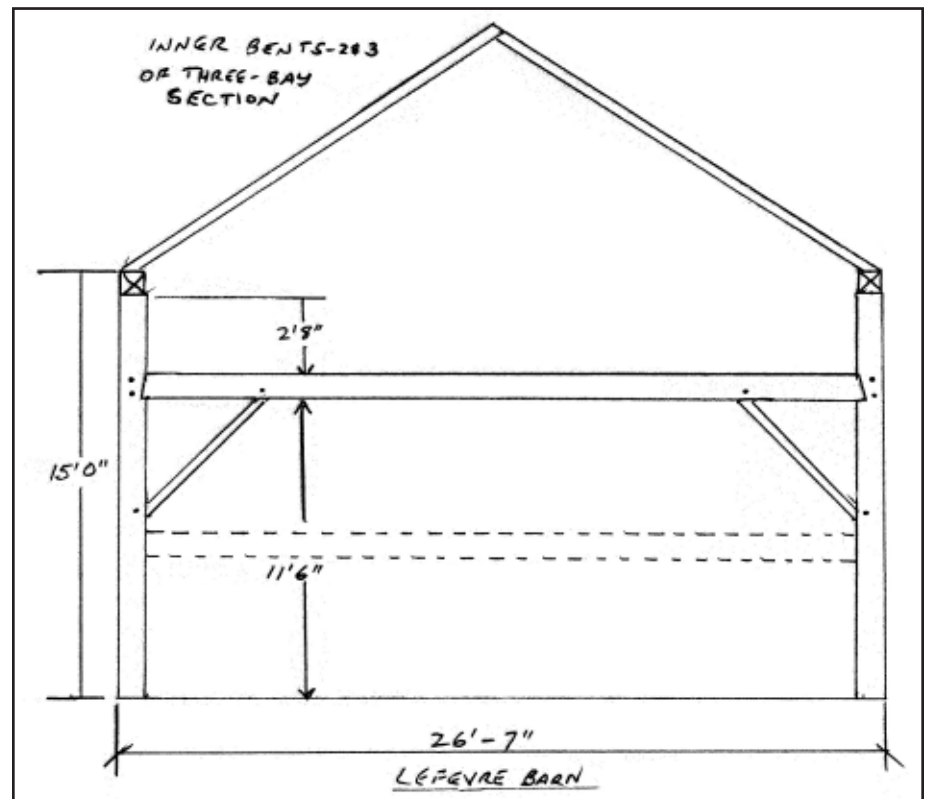
Figure 1. Section showing an inner bent of the three-bay section, with a high-placed beam with end braces and side wall posts. Below the beam, indicated by dashed lines, is the former position of a second beam.

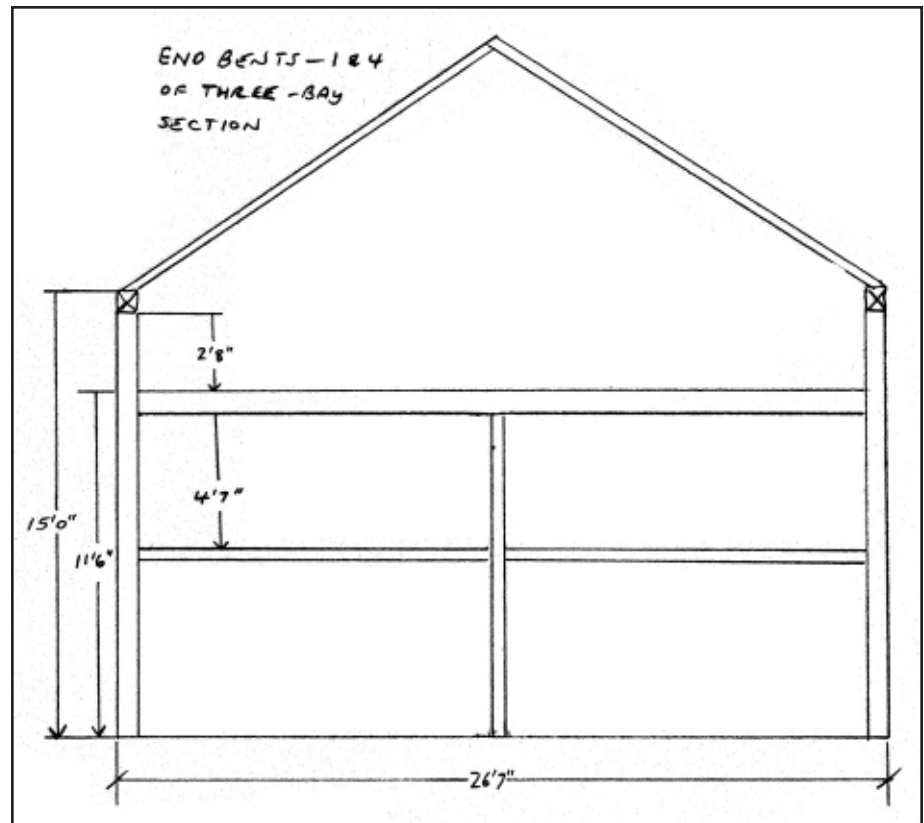
Figure 2. An end wall bent of the three-bay section, depicting the anchor beam and side wall posts along with lower half-span beams that join to a mid-span vertical post. No braces or end wall studs were recorded, but they likely existed.

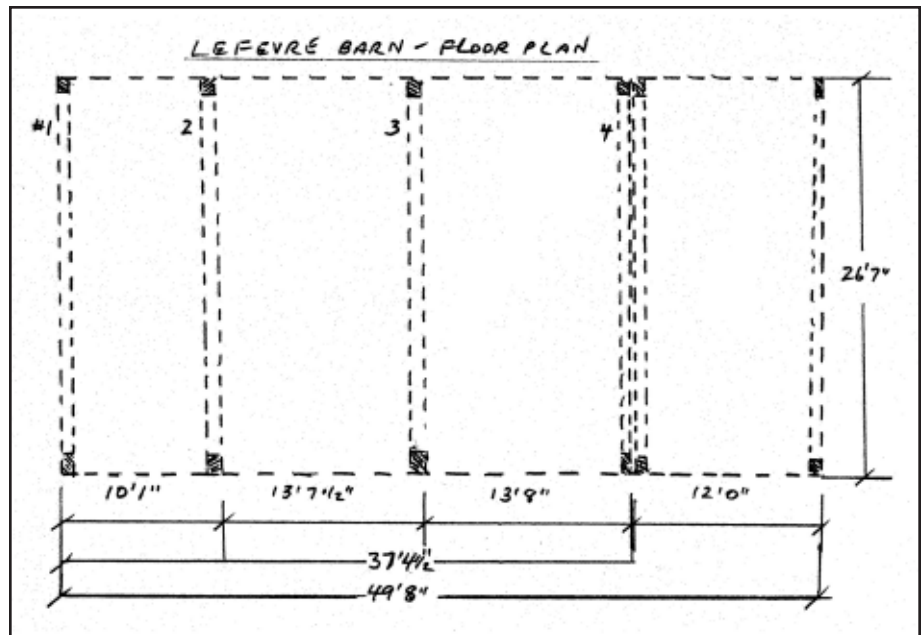
Figure 3. Floor plan showing the original three-bay section at left and the one-bay-wide addition on the right. This sketch does not depict the side-wall wagon entries or the mid-span posts at the end bents of the three bay section.
