# DUTCH BARN PRESERVATION SOCIETY NEWSLETTER

## TWO NEW FORMS OF DUTCH-AMERICAN BARNS?

By Gregory D. Huber

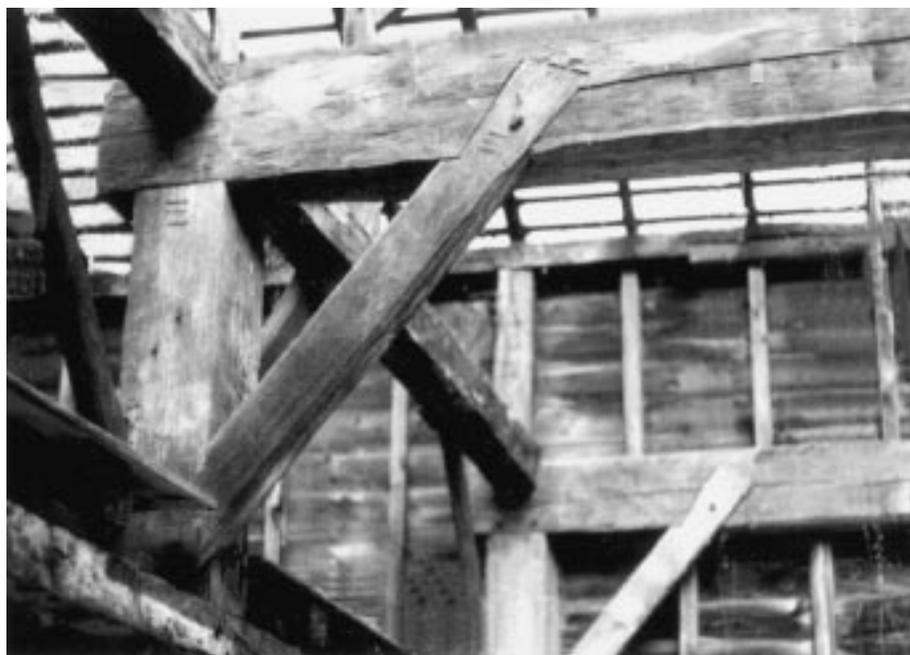
Fig.1 **Blauvelt Barn** – Barn with roof removed. Framing scheme of *dekbalk* construction with post of bent tenoned into horizontal tie. Bent braces with lapped half-dovetailed tenons. (Photo – Claire Tholl)

In the Blauvelt barn, main structural framing units were in the form of *dekbalk* construction. In each unit, a horizontal tie or *dekbalk*, was mortised near its ends into which were inserted the tenoned upper ends of each of the two vertical end posts of the bents. The mortises in each *dekbalk* measured 2-3/4 inches wide and 11-3/4 inches long. Each *dekbalk*, of tulipwood (*Liriodendron tulipifera*), was a few inches shy of 27 feet in length, thus the nave was over 25 feet in width, substantial by Bergen County standards. Their cross-sectional dimensions were about 12-3/4 inches thick by 15 inches high. The tie oversailed the post by a few inches and there was, of necessity, no post extension above the tie and therefore no *verdiepingh* of which to

speak. As a natural consequence of this, no raising holes were present. Two narrow pegs united the end of each tie to each post. Purlin plates were set into 9 inch wide recesses at the top surface of the *dekbalken*. The outer edges of the recesses were about 5 inches from the very end of the tie beams. End braces with lapped half dove-tailed tenons united the ties to the posts of the bents. Distinct marriage marks appeared at each tie and post juncture and at the top of the braces. Three *dekbalken* were in evidence in the Blauvelt barn. At least one *dekbalk* unit had been definitely removed many decades ago as the precise manner of the framing of the bent's braces indicates.

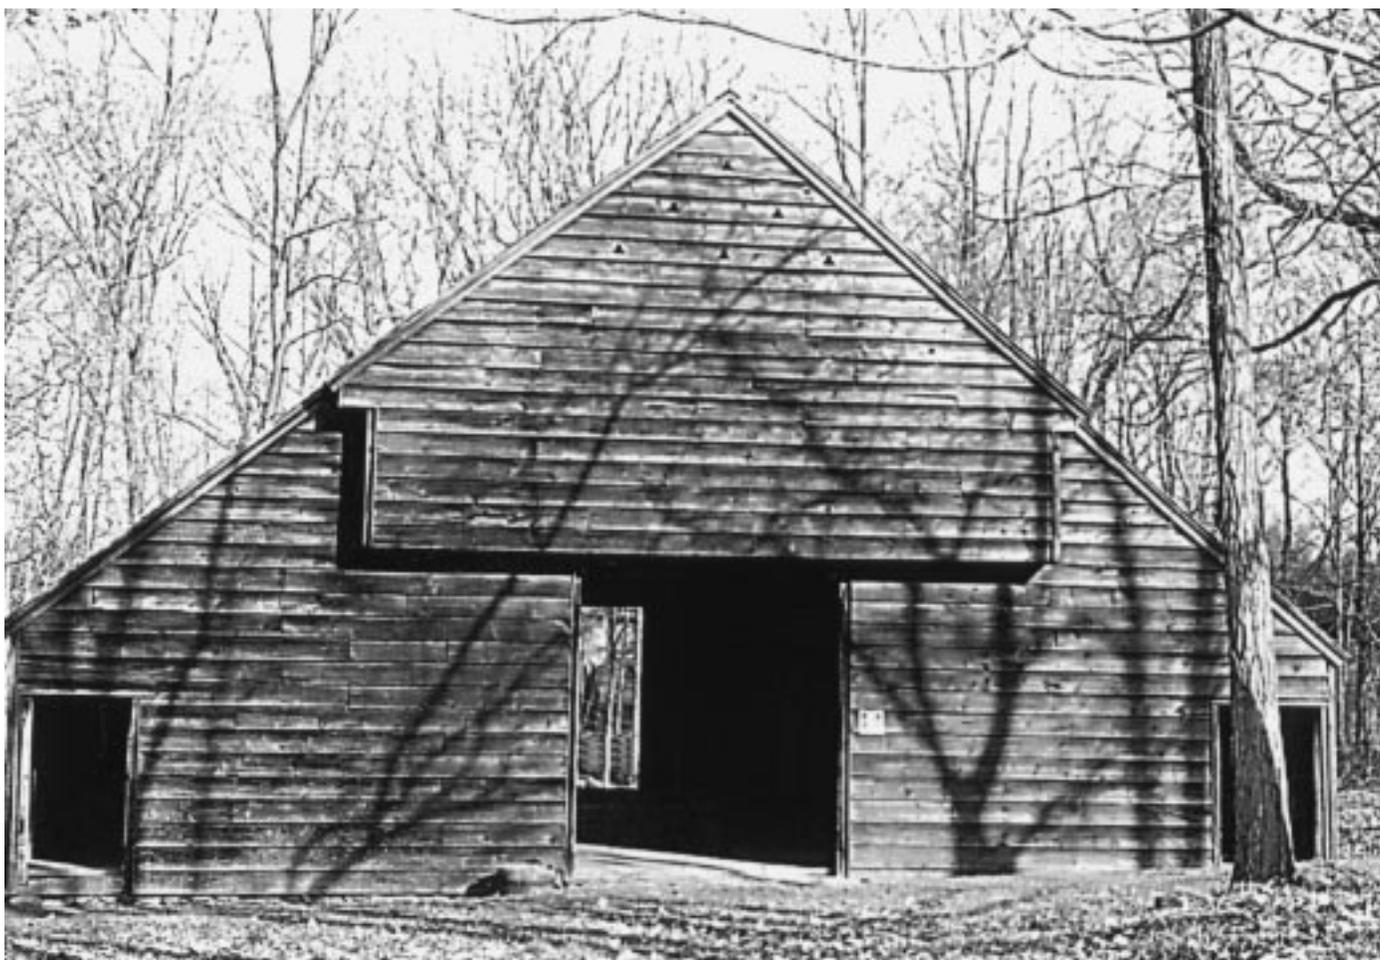
Fig. 2 Verplank – Van Wyck Barn – Exterior of end wall with five-sided cantilever. This circa 1765 three-aisle barn was relocated from its original location near Sprout Creek in the early 1970s to Mount Gulian. (Photo – Greg Huber)

In addition to the well-known and re-located barn at Mount Gulian in Dutchess County, New York, with its five-sided cantilever, the Ho-Ho-Kus barn was the only other extant barn with an intact cantilever. Photographic and structural evidence shows that at least five other structures were known to have cantilevers. <sup>(6)</sup> These included the VanderVeer and Van Pelt barns in Brooklyn, the Dey barn in Totowa, New

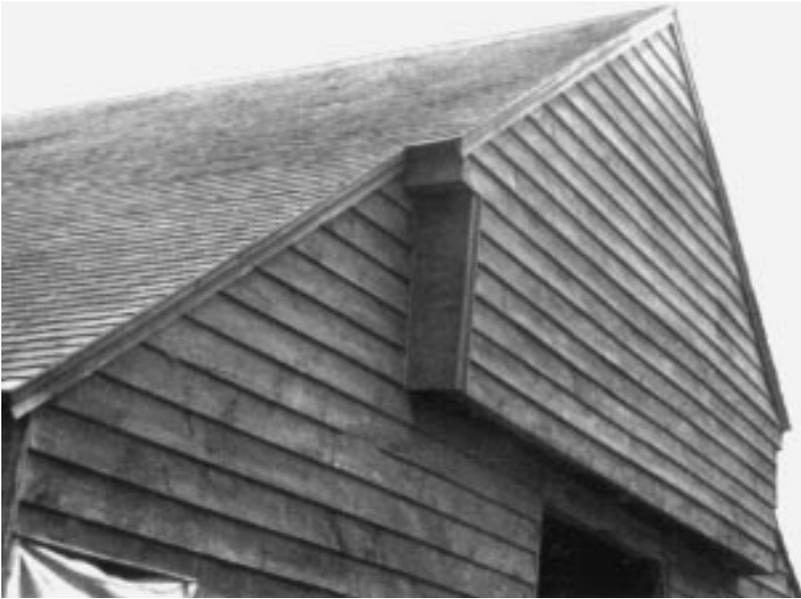
Fig. 3 **Verplank – Van Wyck Barn** – Exterior close-up of upper section of end wall. View of side wall of cantilever in line with purlin plate. (Photo – Greg Huber)

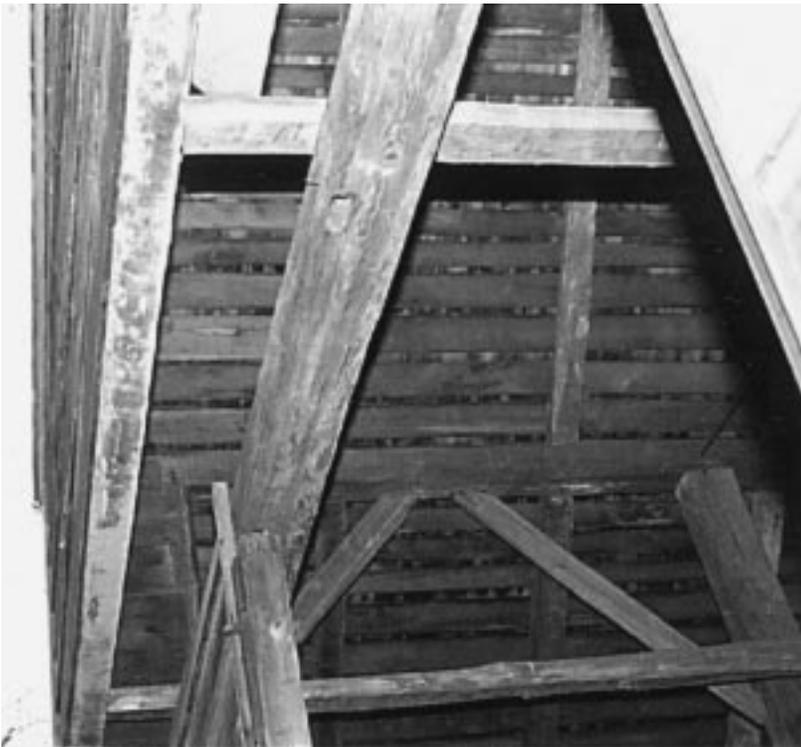
Fig. 4 **Verplank – Van Wyck Barn** – Interior close-up of base of cantilever, looking up. End wall anchorbeam is seen in middle of photo. Base of cantilever is framed with timber 18 inches to left of anchorbeam that forms opening to interior of barn for possible ventilation of crops and protection of threshing doors during inclement weather. (Photo – Greg Huber)

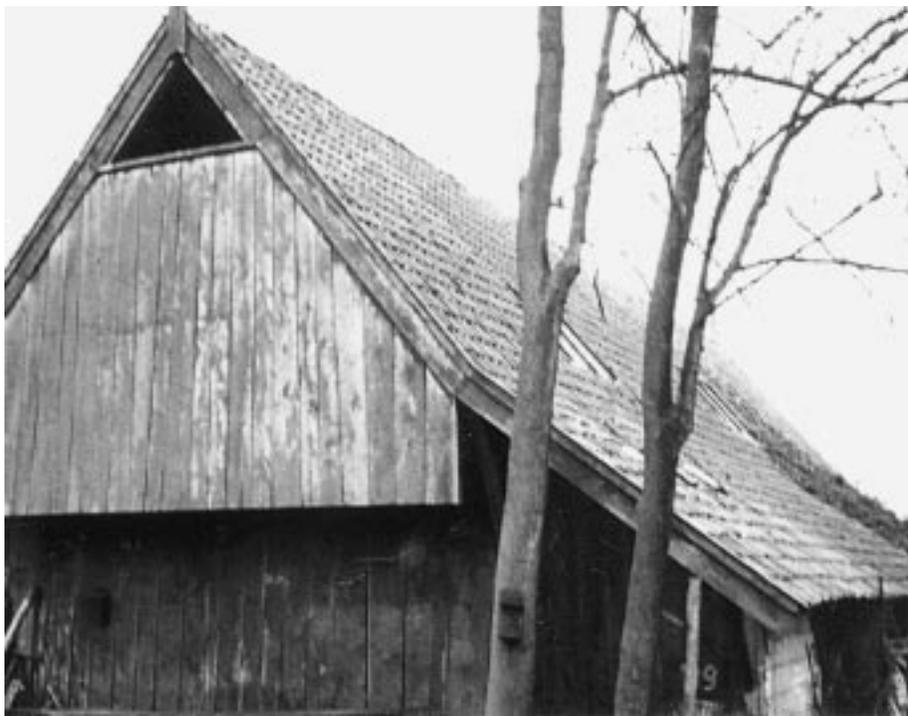
Fig. 5 **Rekken Barn** – Exterior of end wall with cantilever. This second half of the eighteenth-century barn is in the Netherlands in the extreme eastern section of Gelderland province near German border. (Photo – Greg Huber)

Certainly, there are a number of barns in the Netherlands and adjacent lowland Germany that closely duplicate the few cantilever barns seen in America <sup>(8)</sup>. One particularly intriguing example is located in the Netherlands. It is within one mile of the German border in Rekken in the northeast section of the Gelderland province. It is a multi-bay structure with *ankerbalk* construction with a very short *verdiepingh*. The barn probably dates from the second half of the eighteenth century. These European cantilever barns were quite likely the prototypes of Dutch-American examples.
