DUTCH BARN PRESERVATION SOCIETY NEWSLETTER

New World Dutch Barns of Bergen County, New Jersey (Part one)

By Gregory D. Huber

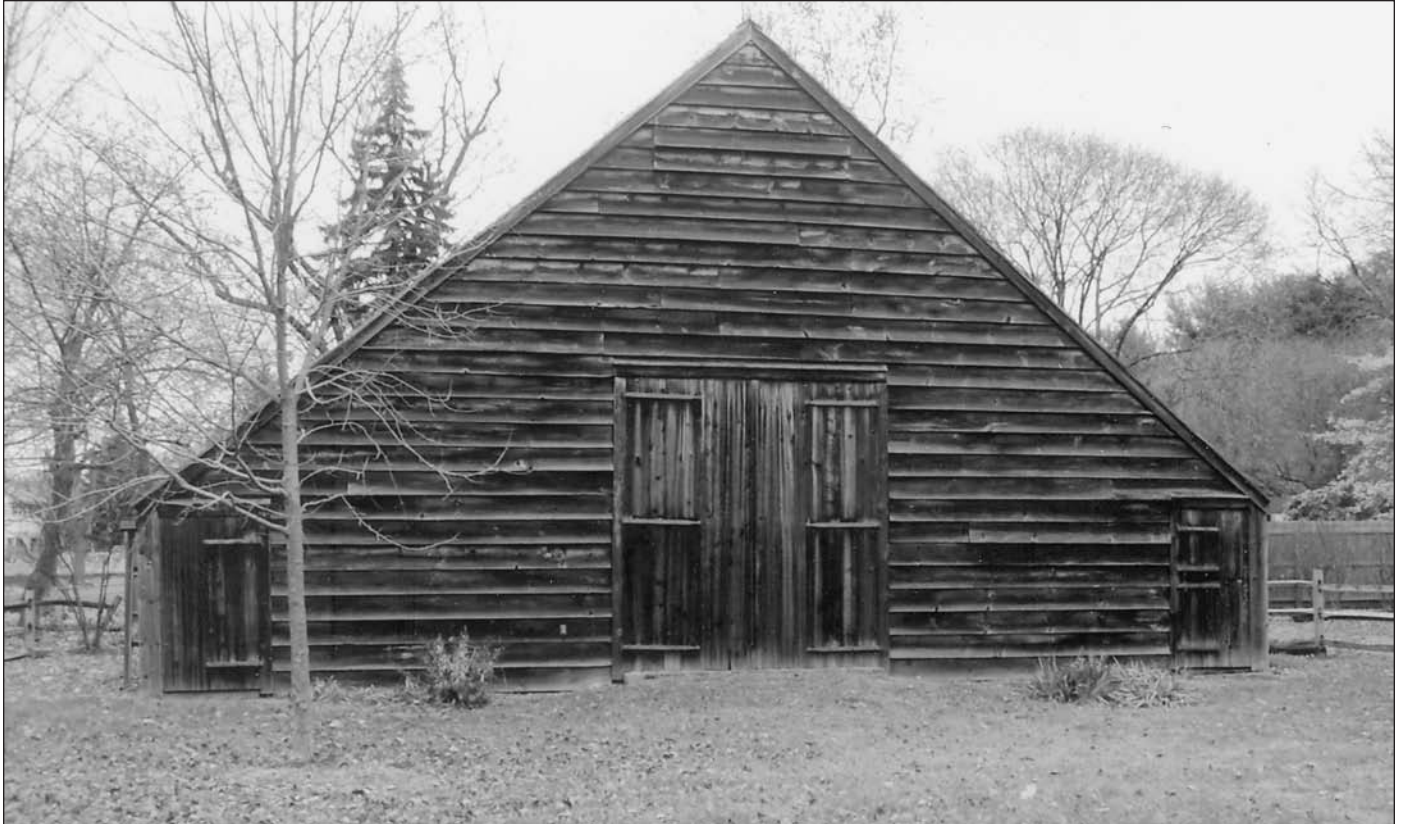
Photo 1. The extant c.1760 (dendro-dated) classic three-bay Wortendyke Dutch barn. Now a museum in Park Ridge, New Jersey, this barn features the lowest side walls—measuring six feet in height—of any known classic Dutch barn in North America. The barn measures 45 feet wide at its gable ends and 37 feet along its side walls. Many of the H-frames are comprised of tulip wood timbers.

Essentially only four observers have reported on the presence of Dutch barns in Bergen County since the 1970s: the late county historian Claire Tholl, historic restoration builders George Turrell and Timothy Adriance, and the author. Claire Tholl authored an unpublished three-page paper in February 1990 (later updated in July 1990) in which she listed and mapped out the locations of 34 barns. Included were five extant classic Dutch barns, seven Anglicized Dutch barns, five barns that had “been lost in recent years” and 17 barns that she identified from photographs, HABS documentation, survey maps and other sources. In addition, she provided a map of Bergen County with locations of four categories of Dutch-type barns that she had come across. These are currently identified as extant Dutch (classic) (Photo 1), non-extant Dutch (classic), extant Anglicized Dutch (Photo 2), and non-extant Dutch-Anglo.

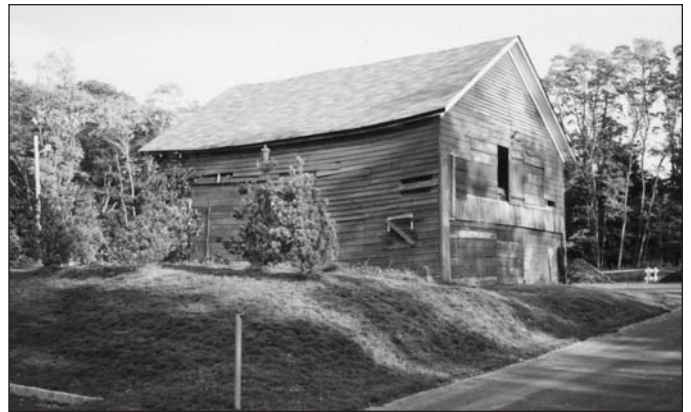
Photo 2. The now-raised Ackerman-Dewsnap Anglicized Dutch barn in Saddle River, New Jersey. This was originally a classic barn that was converted into a side wall entrance barn and only two of the original bays were retained. The barn was removed from its site about 1993 and its timbers were placed in storage.

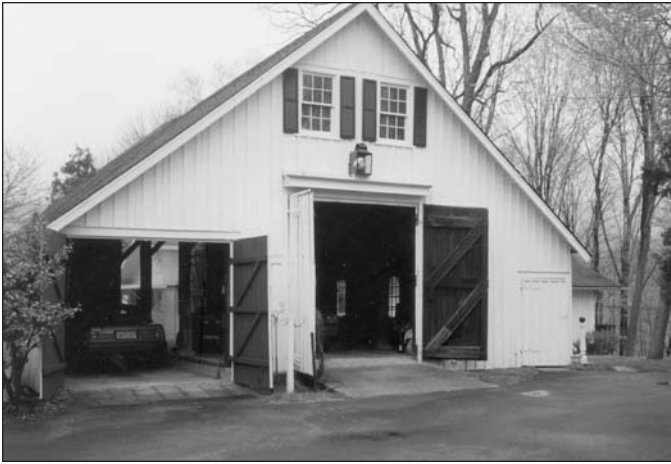
Photo 3. The extant c.1790 classic three bay Bartholf Dutch barn in Mahwah, New Jersey. This barn features nine foot high side walls. It measures 36 feet at its gable wall and 30 feet along its side walls. Exterior siding and gable doors are not original.

general sense of the proportions of the classic Dutch barns constructed in the county (Photo 3). These exterior depictions can lend only a general sense of certain interior details such as post extensions above anchorbeams (*verdiepingh*) but little else of the interior features of these barns (Photo 4).

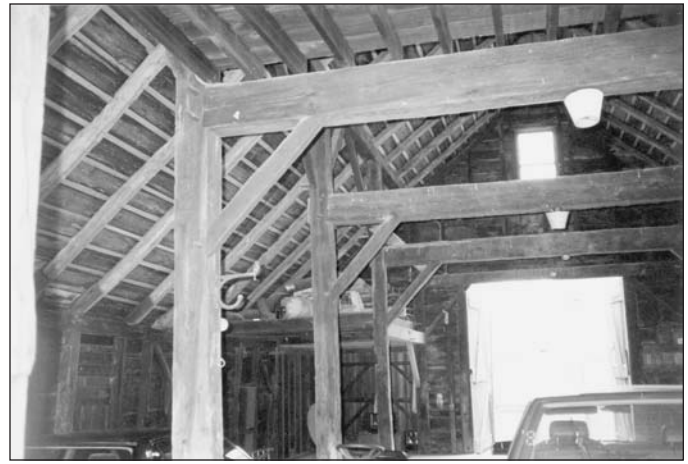
Photo 4. A second view of the Bartholf barn. The barn has an added bay at the northwest gable wall. Oak (and possibly chestnut) timbers comprise the H-frames. Anchorbeam tenons extend only about two inches with no wedges.

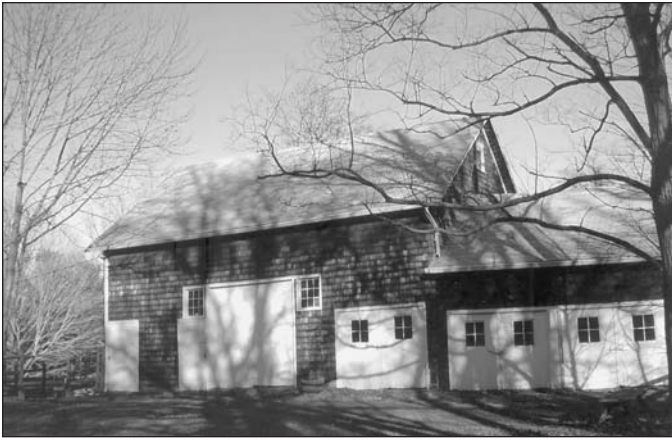
Photo 5. The extant c.1840 three-bay Anglicized Dutch barn in Montvale. In its original classic form the width of the nave was 18'-1" and the original side wall length was 30'-3".

Nine distinct types of barns have been identified by this study: five classic barns, six Anglicized Dutch barns (Photo 5), one barn converted from an Anglicized Dutch barn to a classic barn, one Dutch-Anglo barn, a classic barn which had only its center

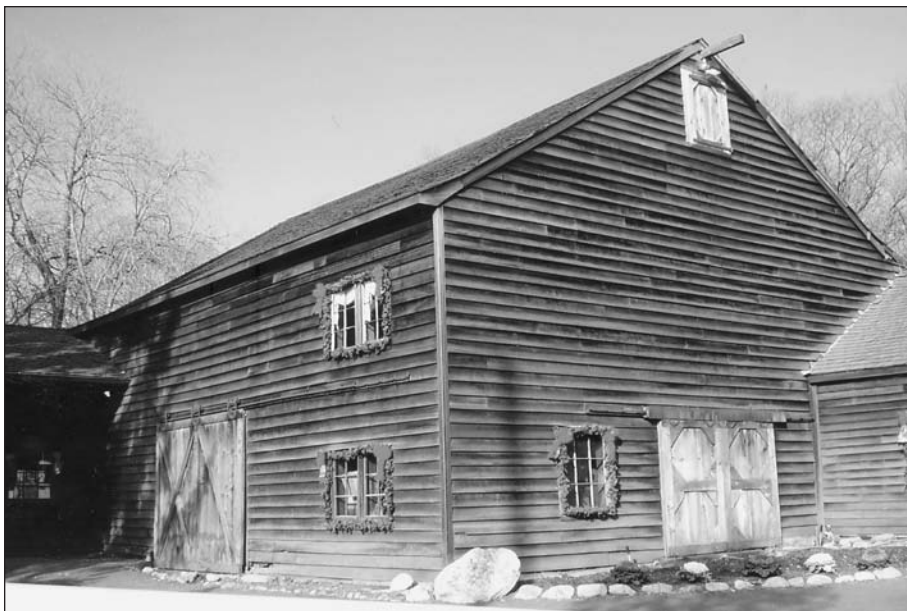
Photo 6. The extant c.1840 Yeoman-Abma three-bay converted "Dutch-Anglo" barn in Wyckoff. In its original classic form the width of the nave was 20'-6" and the original side wall length was 34 feet. Homestead is currently a fruit and vegetable farm.

7. Width of Side Bays. This measurement concerns widths of each of the side bays in barns that were converted from the classic style form to an Anglicized Dutch barn. Briefly, Anglicized Dutch barns of this type were brought about by the removal of the roof and rafters. In most cases the side aisles were removed and replaced by the construction of new side bays. A new roof superstructure, the ridge of which was oriented perpendicular to the original roof orientation, was constructed over the H-frames and new side bays. Sometimes the new side bays were the same or close to the widths of the original side aisles of the classic barn. This type of barn conversion was far more common in New Jersey than in New York (Photo 6).

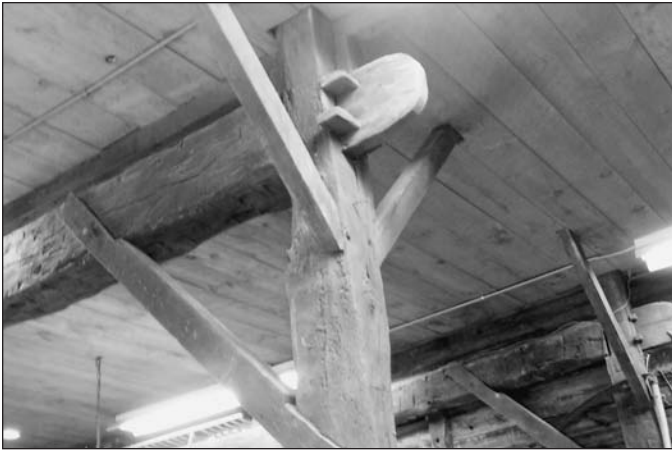
Photo 7. An interior photograph of the Yeoman-Abma barn. Prominent in this view is a 13" anchorbeam tenon extension with double wedges. The purlin braces that extend below the anchorbeam are quite typical of Bergen County barns. Note the H-frame braces with lapped half-dovetail joinery.

Jersey and much of New York State. The average range of tenon extensions in pre-1820 barns is about eight to 12 inches. Two foot tenon extensions appear in two New York barns (Photo 7).

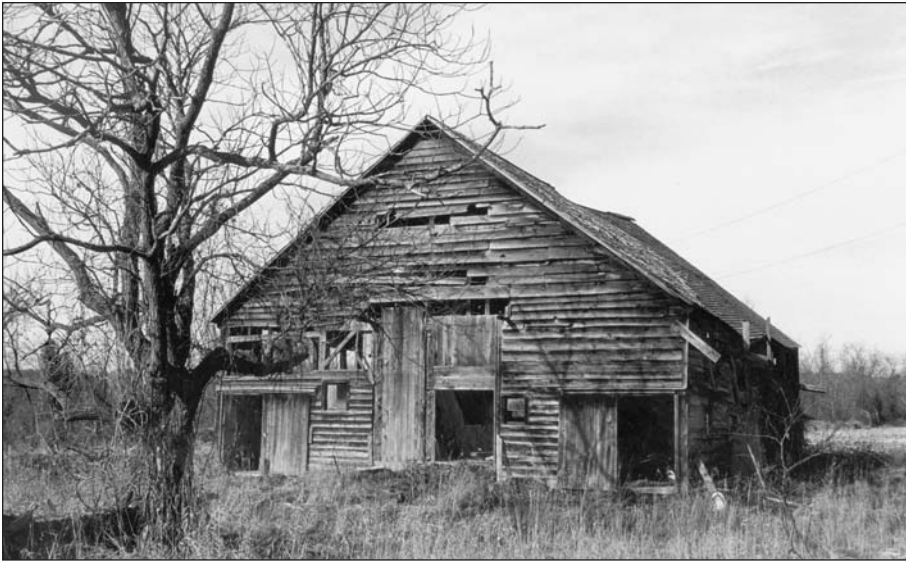
Photo 4. Exterior view of the barn by Erin Willsey, 1990.

The center for all this farming activity was the three-aisle Dutch-style barn located on the rich dirt bank of the east side of the Switzkill (Photos 4 thru 6). In the 1950s, I was told that the barn was over 100 years old. I believe the Dutch barn was built around 1790 by Adam Dietz Jr. The 1784 will of John Henry, Adam's father, stated that "Adam, my son, should build a barn, and my beloved wife should pay one half of the charges out of the land I have given them." I believe that Adam, already married 15 years, had his own house on the west bank of the Switzkill behind the later-built Robert Ball farmhouse, but shared his father's barn across from the Drezlo farmhouse nearby where John Henry lived. Clyde Ball told Alberta that this site on the Switzkill was the original homestead of Maple Ridge Farm and she discovered pots and plates there as a child. The unrecorded deed from 1812 that transferred the 95 acres of the Adam Dietz Jr. premises to son John Bellinger required John to pay his share of Van Rensselaer rent. The annual rent for the entire 159-acre Adam Dietz Jr. farm was 18 bushels of wheat, four fat fowls, and one day's labor (with horse and wagon).

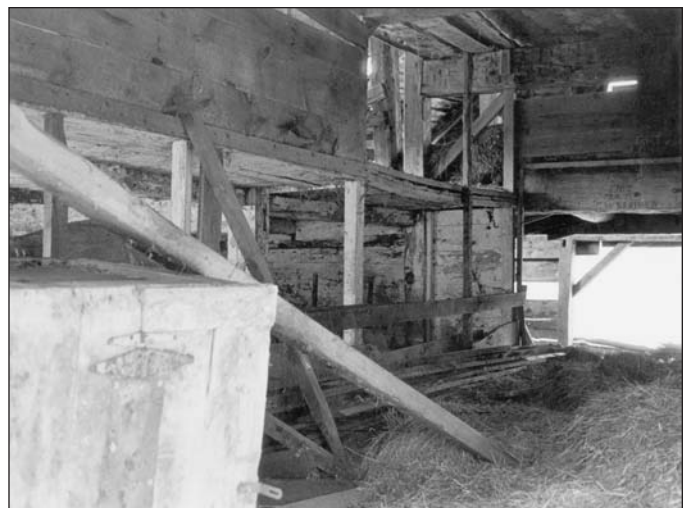
Photo 5. General interior view by Erin Willsey, 1990.

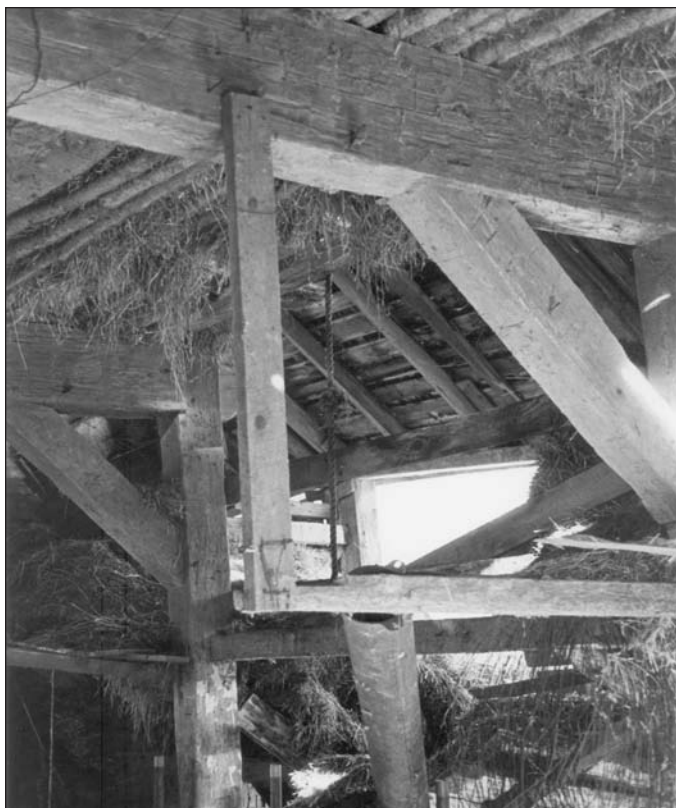
Photo 6. Interior photo showing anchor beams by Erin Willsey, 1990.
